LEARN BEA'S PRELIMINARY REPORT ON LUFTHANSA CRASH

Dr. Sohei Matsuno¹⁾, MS. Pujiono T.²⁾
¹⁾ Professor, RPLM, ²⁾ Lecturer, BAT,
University IBA, Palembang, Indonesia,
E-mail: sohei_matsuno@yahoo.com

Keywords: Lufthansa / AirAsia crashes, analogy between airbus crashes, bulkhead fatigue

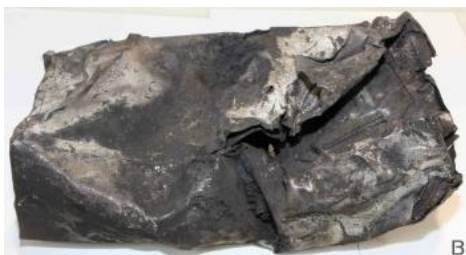
Photo 1 Damaged FDR of crashed A320 (Origin: www.pilotman.net, www.bea.aero)

As seen in **Photo 1 (a1)** and **(a2)**, its front interface and memory module protection casings had been deformed, tore, and exposed to heat. It implies that the memory module **Photo 1 (a3)** had a direct thermal effect of conduction and radiation.

(a1) Front interface casing

(a2) Module in protection casing

(a3) Module

BPR says FDR was covered by *soot*. The soot comes from smoke. The smoke is from fire. But there was no fire in this crash. Hence, no soot could be. So-called soot is degenerated surface treatment materials of FDR. Then, where did the heat come from? Well, the heat didn't come from external conflagration out of the FDR casings. It was internally generated in the casing itself when it was subjected to an instantaneous cold-work (deformation to tearing) at the time of crash. If the heat would be from an external origin, e.g., a fire outside the casing, it should take time until heat reaches the memory module by conduction, and could be isolated by an insulation-layer placed in the space between the casing and the module. However, if the heat is from an internal origin, e.g., generated by the cold work in the casing itself, heat instantaneously reaches the module in which a memory card is located. Much more, the memory module was being stripped off with its protection casing and insulator. The effect of heat was severest at the front side in **Photo 1 (a2)**, since generated heat was greatest (casing destruction was greatest) there, and heat protection was effectively 0 (the insulation layer was striped off from the position). In this context, the data recorded in this side were in the most vulnerable condition. Remember! The digital data in the memory card is susceptible to heat.

Given the situation as the above, it is hardly possible to imagine that the memory card in the module is intact. BPR says in its Article: *1.8.3 Synchronization of recordings, 'The FDR recordings then were synchronized with those of the CVR using the radio communications with the control centre, the triggering of the GPWS alarms and the Master Warning parameter.'*

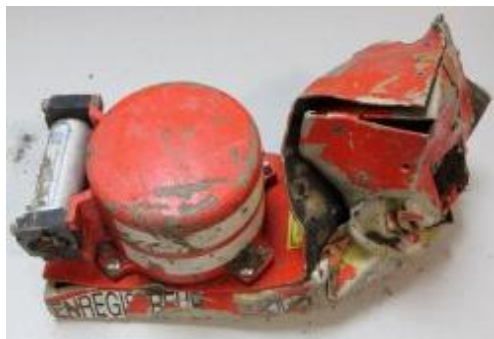
Photo 2 Damaged CVR of crashed A320 (Origin: ditto)

Photo 2 shows the mechanically damaged CVR of the crashed Airbus.

As seen in the photo, CVR's memory module protection casing (left part in **Photo 2**) doesn't show significant mechanical damage. Further, analog data are less susceptible to shock and heat than digital ones are. Hence, voice / sound data recorded in it may be able to be readout. However, its recorded time data disappeared as they were digitally recorded. It needed the

synchronizations. More crucially, its analog data (sounds) were weakened by decompression, as the medium of sounds (air) was rarefied by the decompression.

Comment: Opaque analog sounds in CVR may be heard as human breaths. It's an act of imagination. But an unclear digital number, e.g., '09 41 ??' shall not be read as '09 41 06'. If dare do it, it's an act of creation.

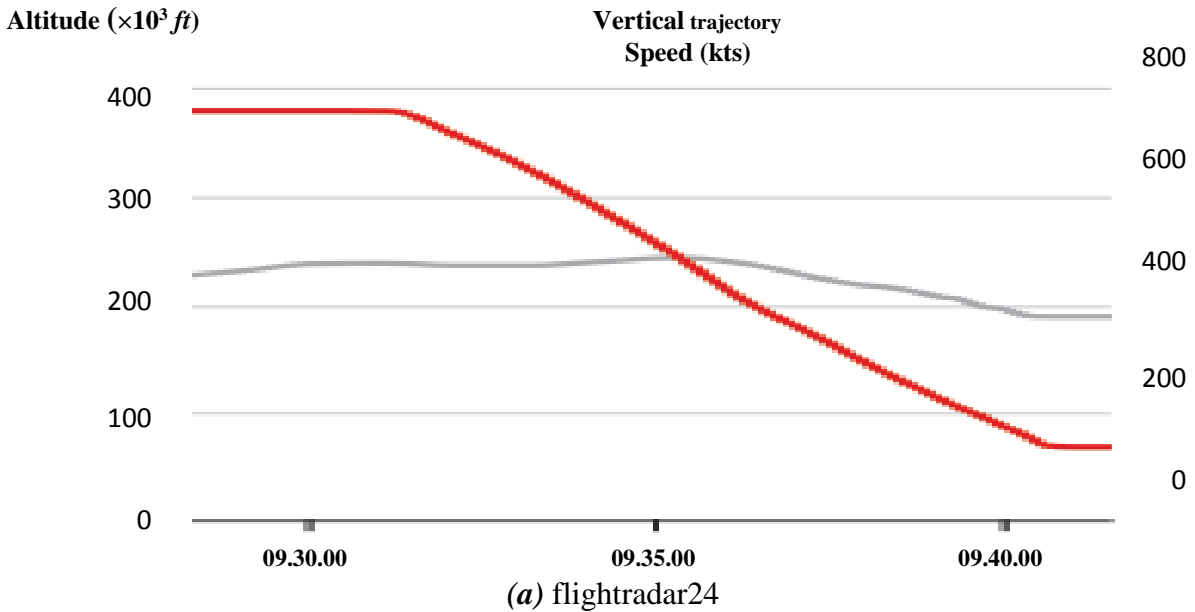
Fig. 1 Altitude Chart of last problematic minutes (differences between FDR and Radar Data)

As seen in **Fig. 1 (a)** and **(b)**, a qualitative difference of the last trajectory between of BPR and of Radar is: if a post-descent level flight existed after $T_{(R)}$. For the sake of easy recognition, the two trajectories of last 60 seconds are illustrated in **Fig. 2** in which the controversial digital values are shown as well.

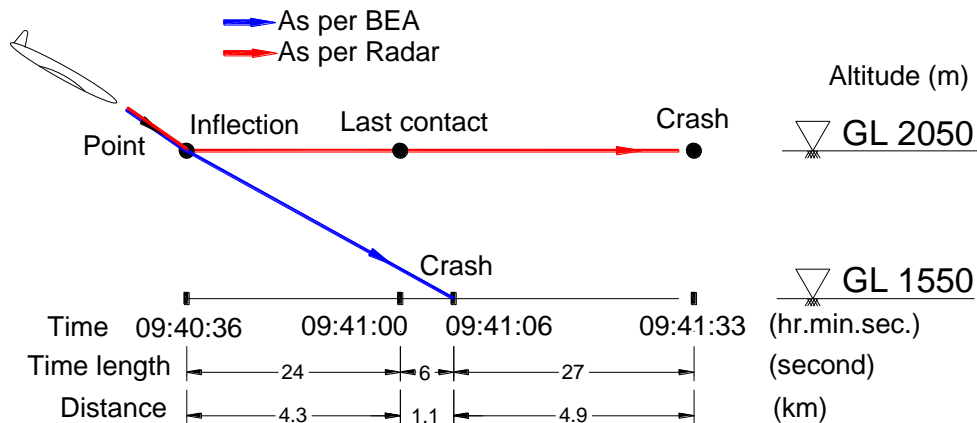
Fig. 2 last 60-second trajectories of BPR and. Radar assumes

After $T_{(R)}$, BPR's trajectory kept the constant motion as it was before $T_{(R)}$, till the time ($T_{(M)}$) when the plane collided against the sloped terrain of 1550-*m* altitude at 09 hr. 41 min. 06 sec.

Radar's trajectory changes its descent to the level flight at $T_{(R)}$, and it didn't change the altitude after $T_{(R)}$, via the last Radar contact time, 09 hr. 41 min. 00 sec. to the time $T_{(M)}$ when the plane collided with the mountainous terrain of 2050-*m* altitude at 09 hr. 41 min. 33 sec.

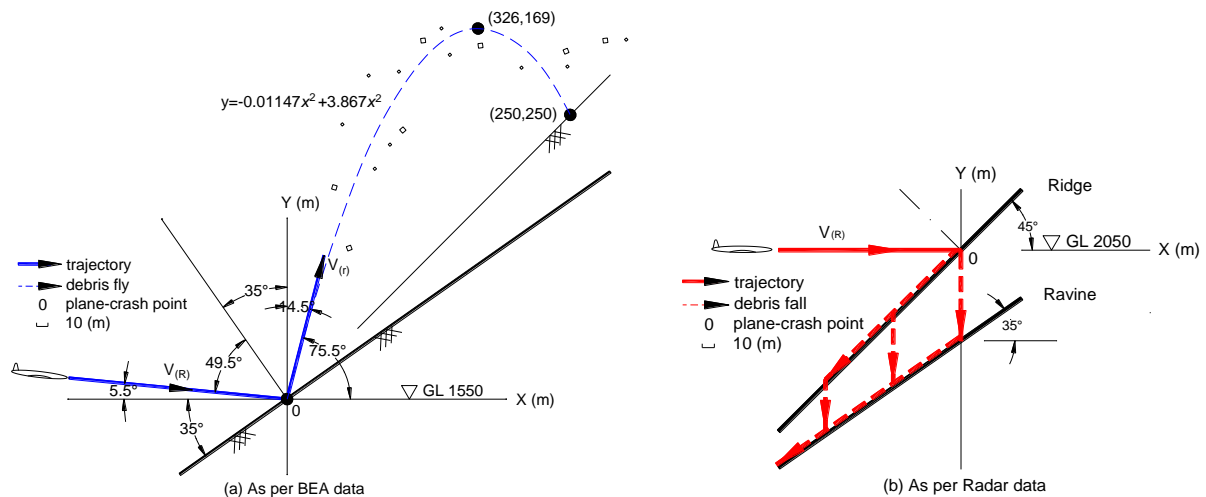
Fig. 3 Geometrical feature of plane collision

The last flight trajectory as per Radar data also qualitatively agrees to the reality. That is, after the crash, the debris of the plane ran down the steep slope due to the gravity force, having scattered about the debris on the ridge surfaces and along the ravines. cf. **Fig. 3 (b)**.

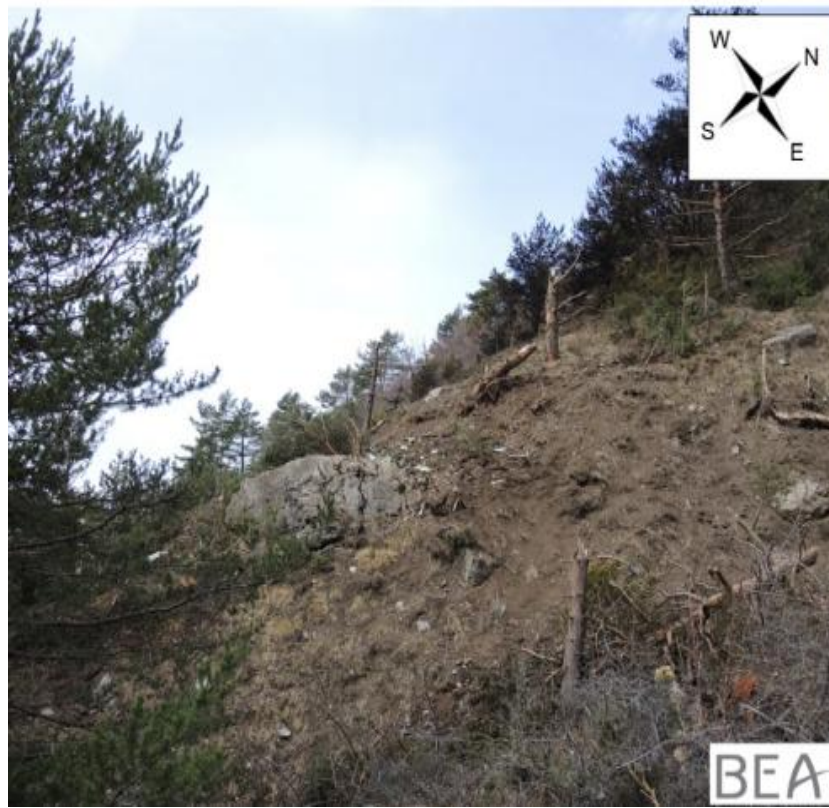
Photo 3 Plane-crash site area (identified by BPR)

The alleged site is seemingly a decomposed granite deposit area. Such a land is generally characterized by slow landslides. **Photo 3** evidences it by a few cliff lines (top of sliding surface) of about 0.5 ~ 1-m high. The mode of the landslide is slow and small. It may occur as frequent as once a year in the end of each snow season. A landslide is caused by water from melting snow. A landslide maybe used to cause a snow-slide of small scale.

The landslide in **Photo 3** is new, happened in this spring. The site may have had occasional, powerful, big scale avalanches in mid snow seasons.

In **Photo 3**, there’re trees broken at about 2-m high from GL. BPR judges they’re the result of a plane collision. If it is so, the trees must have been broken at GL where the maximum

There're disturbed ground surfaces in the photo. BPR says it was churned by the plane crash. It is a trace of ground erosion by the melt-and-flow water at the end of this snow season.

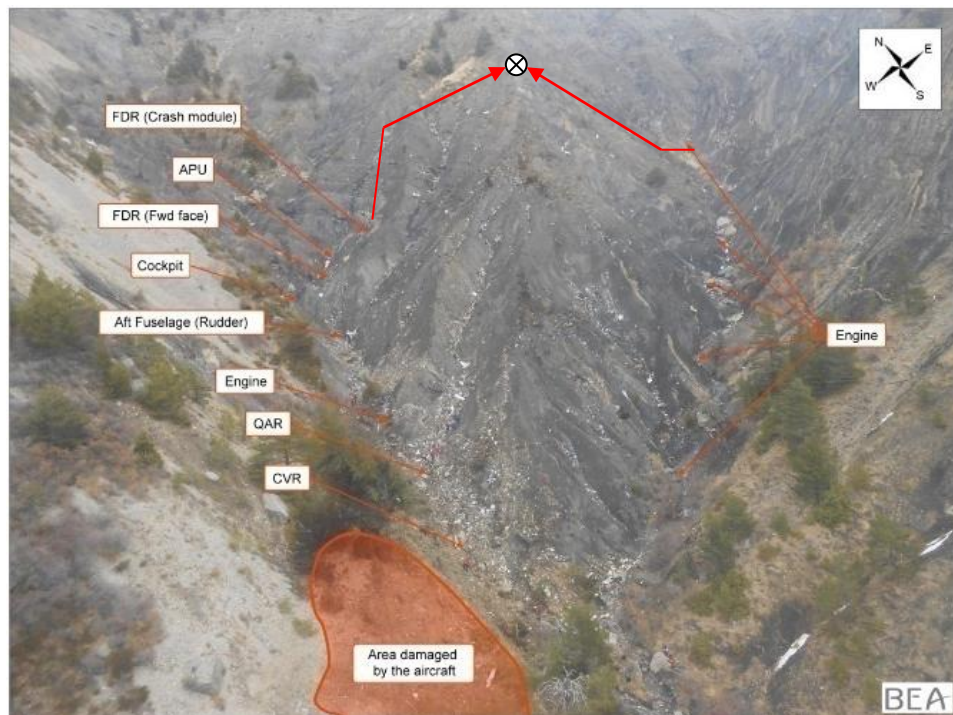
Photo 5 Plane-crash site of BEA (red hatched area) and this Report (× marked point)

Photo 5 shows an ‘*area damaged by the aircraft*’ with red hatches. It is a landslide area caused by melting snow and followed by snow-slides.

This Report explains the plane-crash pattern as follows: cf. **Photo 5**.

(i) The plane flew horizontally and collided against the ridge summit of 45(°)-slope with the plane’s joint of the right wing. (ii) The fuselage was deformed to flat and smashed to pieces. There was no rebound (cf. 13 lines in page 13~14). (iii) The slope of the surfaces of both side of the ridge is about 45(°). (iv) By gravitational force, the elements pertained to the right wing fell down along the east side ridge surface and other elements fell down the west side ridge surface, down to ravines at both sides of the ridge. (v) The debris further rolled/slid down the ravines of 35(°). (vi) While they were falling down, some elements came to halts along the ridge’s side surfaces and most of debris at ravines. (vii) Many of them stopped at the lower ravines where their slope is relatively lenient, 25 (°).
